Samphire Hoe Gully Erosion

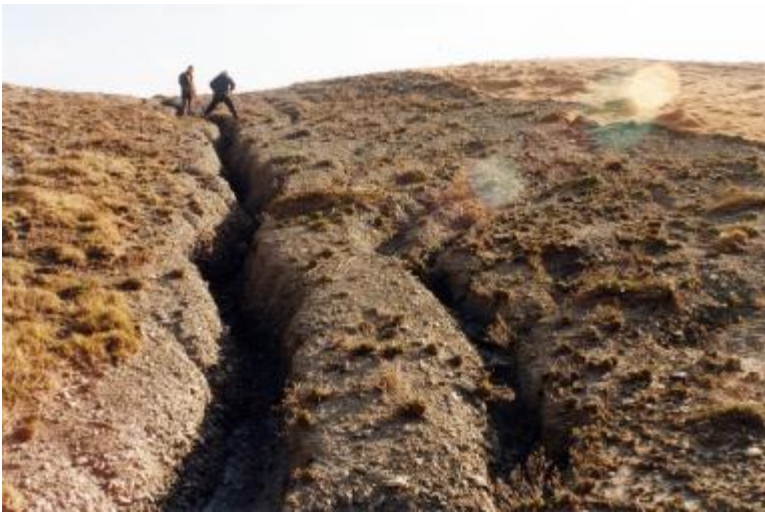
Top: Badly eroded gully on coastal site

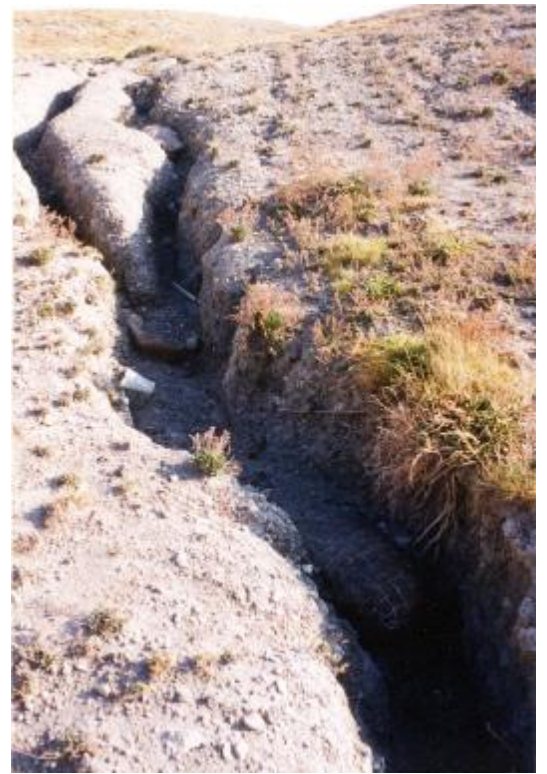
Top right: Initial silt deposits using Hy-Tex CoirLogs

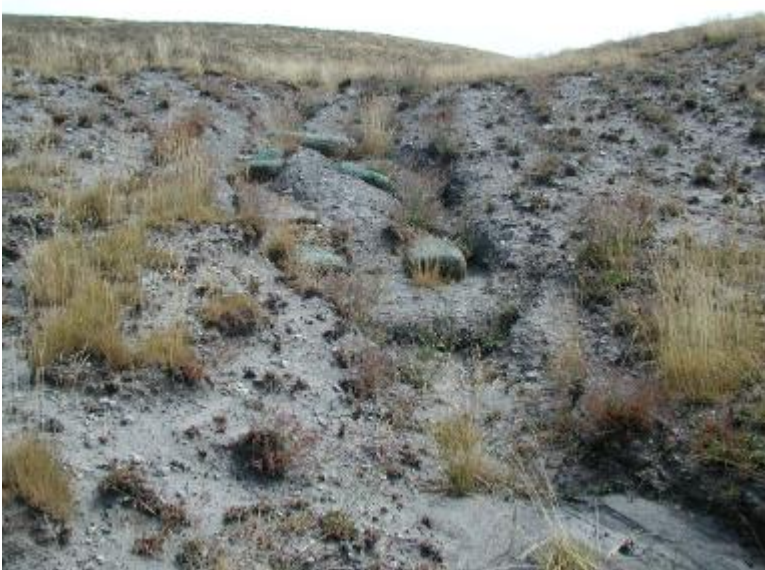
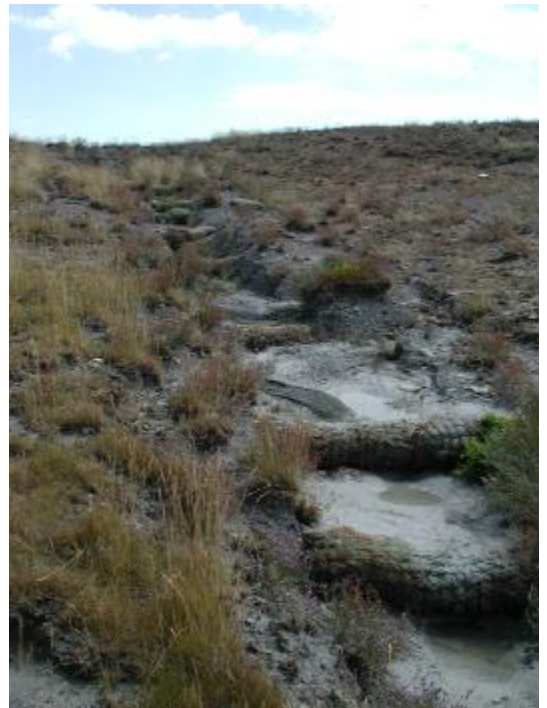
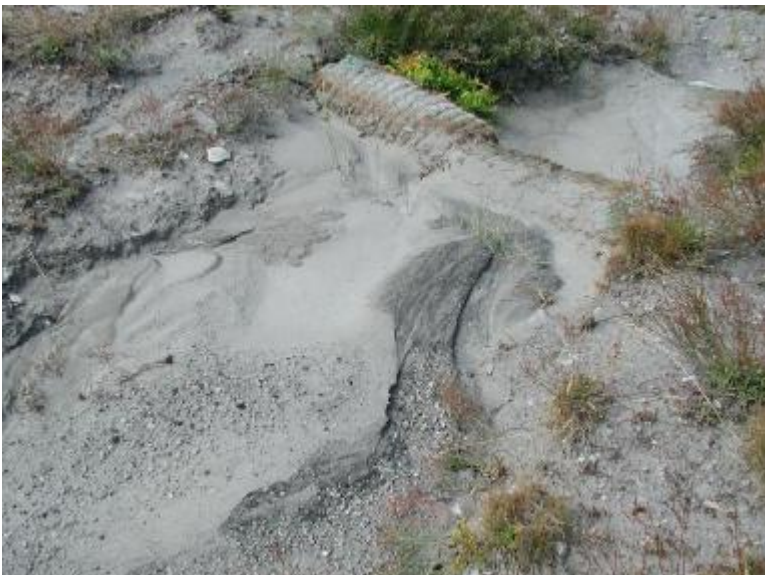
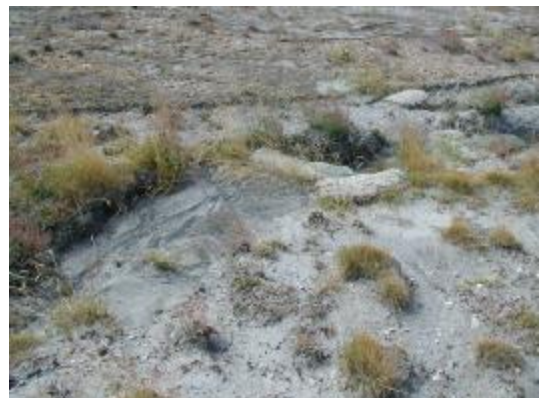
All below: Current level of reinstatement using only Coir-Logs
